# POOL INSPECTION

**March 26, 2024**

**ACCURATE POOL INSPECTION**

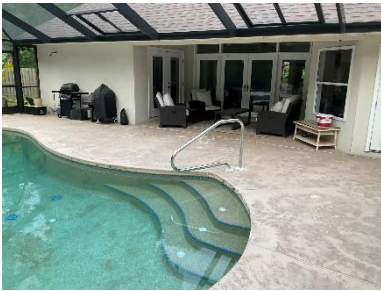
### **1. Pool Deck:**

The concrete deck has an acrylic coating. The deck has been expanded to accommodate the lanai. The extended pour needs to be colored and textured. The deck is overall level with only minor fractures in the acrylic overlay. The deck has a stainless steel handrail at the stairs. It is pulled up and needs to be secured. There is another rail at the swimout.

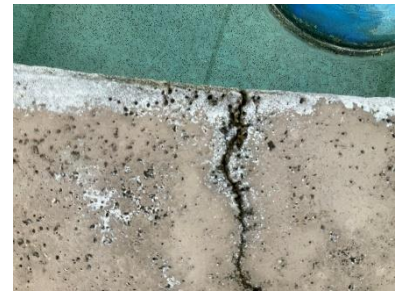
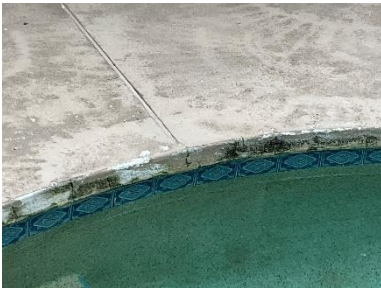
### 3. Coping:

The coping of the pool is a concrete square edged band with an acrylic coating. The coping has mild cracks, but is in overall serviceable condition.

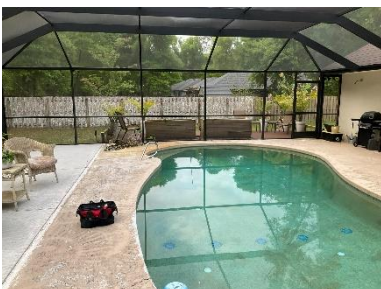
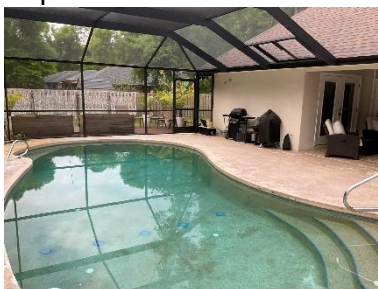
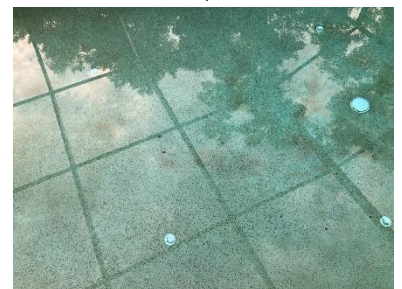
### 1. Interior Finish of Pool:

The plaster surface is an older pebble surface. It has signs of deterioration and several areas that have delaminated. The surface is heavily stained, primarily due to age. The surface remains in serviceable condition. An acid wash could greatly improve the aesthetics. The quote for an acid wash is \$1800.

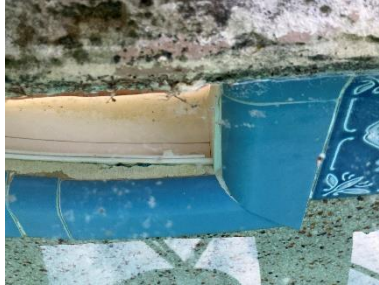
### 3. Skimmer:

The pool is equipped with a single skimmer. It is dressed with a lid and basket.

There is a suction cleaner fitting in the skimmer.

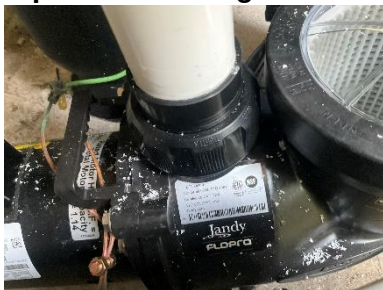
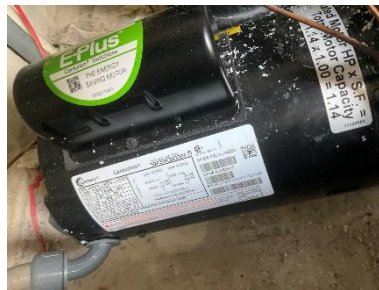
### 1. Pump & Motor:

The pool equipment is located in an equipment room that is built onto the back of the house. The pool is equipped with a Jandy FlowPro pump and motor that is new and functioning as intended.

**\*\*\*As part of routine and preventative maintenance, it is suggested that all o-rings and gaskets be replaced at change of ownership.**

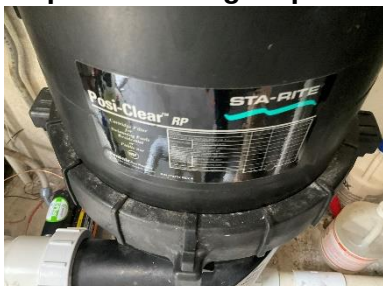
### 2. Filter:

The vessel is equipped with a Sta-Rite Posi-Clear PCCF150 cartridge filter. The filter was installed in 2018 and is functioning as intended.

**\*\*\*As part of routine and preventative maintenance, it is suggested that all filter media (cartridge, DE or sand) be replaced at change of ownership. This is routine and sanitary maintenance. Filter media not inspected during inspection as it is assumed it will be replaced with change of ownership.**

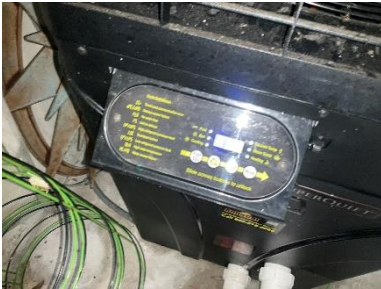
### 3. Heater: Repair Recommended

The vessel is equipped with an Aqua Cal heat pump heater located inside an enclosed equipment room. The heat pump discharge requires fresh air that has not been discharged from the heater. The unit has an error code. The heater needs to be serviced and needs to be removed from the enclosed space. Recommend assesment by local Aqua Cal representative. Approximate price to move heater is \$1200.

The GoldLine solar system is not functioning.

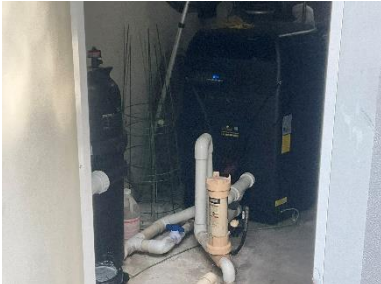
### 5. Pipes at the Equipment:

No leaks or fractures at equipment.
